## North Coast Regional Water Quality Control Board

**Inspection Report for June 21, 2019 Inspection**  
**Humboldt County Assessor's Parcel Number 217-381-008-000**

FILE: Cannabis Regulatory Program Inspections, John Quinn Property,  
Humboldt County, CIWQS Place ID 844276

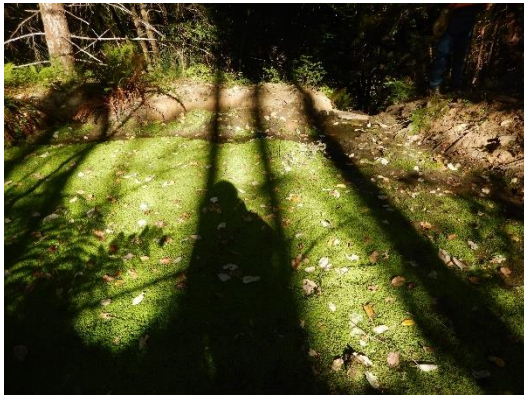
To the west of TOC2, I observed the headwaters of a second watercourse, TOC1 (Photos 2-3). TOC1 contains evidence of channelized flow and is located within 30 feet of OG1. Just downslope from TOC1, I observed a substantial amount of slash from land clearing activities associated with the development of OG1, burying any evidence of a continued channel below TOC1. Further downslope, along the contours associated with TOC1, I observed a small impoundment, P1 (Photo 1). P1 consists of a small earthen dam comprised of hand-excavated native fill, including a spill way that diverts flow into a class III watercourse. The spillway does not contain adequate erosion control and flow conveyance infrastructure. TOC1 was not disclosed in the WRPP, and P1 was not adequately discussed in the WRPP.

Photo 1: P1, outfall visible in the background

2. In the case that the landowner intends to keep or replace the impoundments observed at locations P1 and P2, ensure that the assessment described under Recommendation 1 above includes the certification of an appropriately qualified, licensed professional, stating that the impoundment meets, or specifying measures necessary to ensure that the impoundment will meet, the following standards:

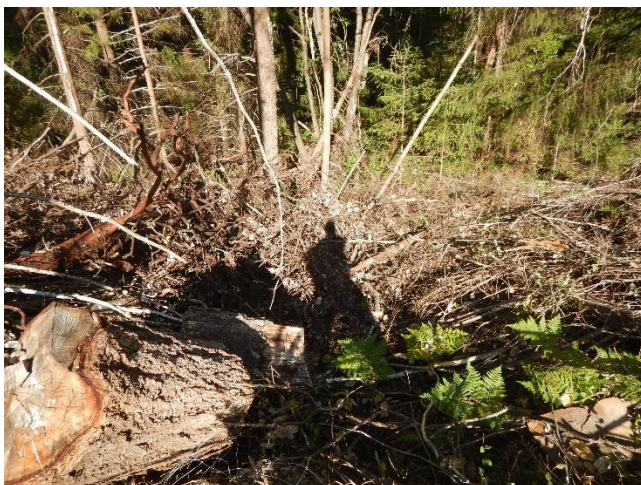
Photo 2: Slash on top of TOC1, channel not visible due to slash

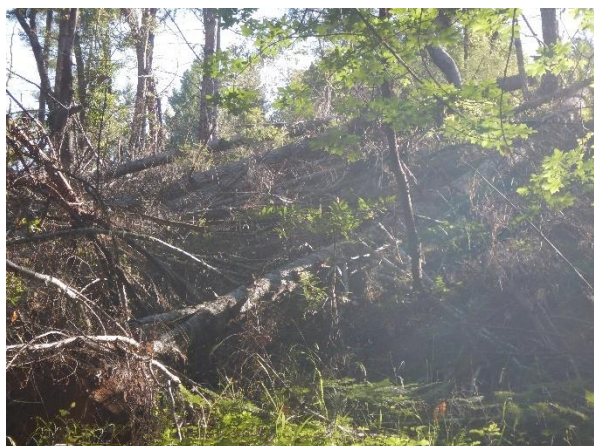
Photo 3: Slash in channel associated with TOC1, photo taken from edge of P1

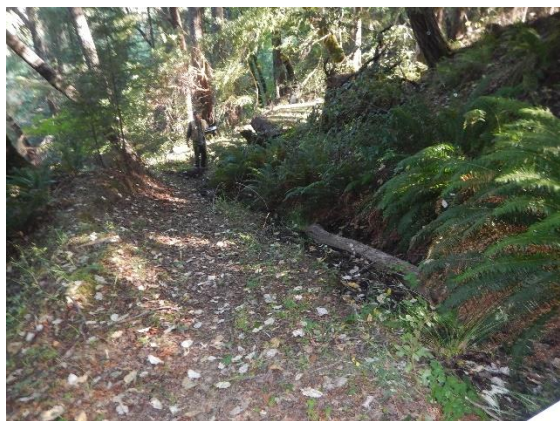
Further downslope from P1, I observed a watercourse crossing along a skid road, C1 on Figure 1 (Photo 4). C1 consists of a ford crossing with no armoring. C1 directs flow associated with TOC1 and P1 into an adjacent class III watercourse. C1 was not disclosed in the WRPP.

Photo 4: Diverted watercourse along skid road with crossing, C1 located where person is standing

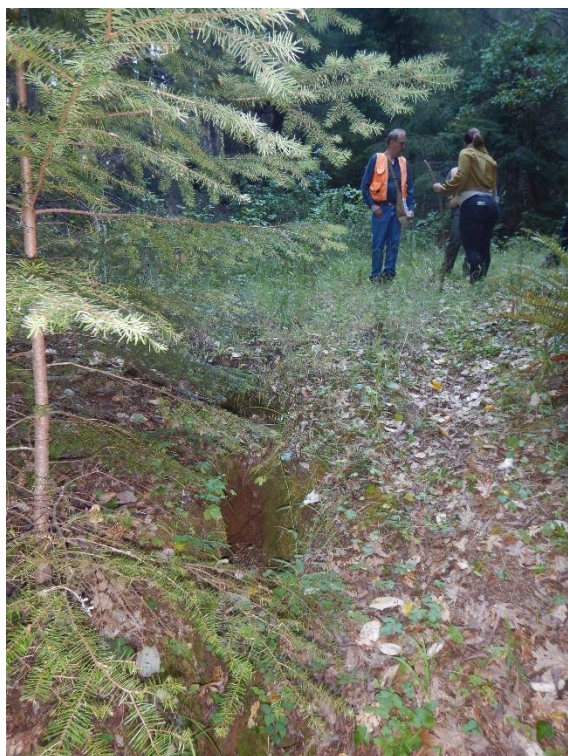
To the south, along the same skid road, I observed a second watercourse crossing, C2 (Photos 5-6). C2 consists of a channel that has formed from water flowing down the skid road, diverting across the road, and delivering to a class III watercourse below. C2 was not disclosed in the WRPP.

Photo 5: Eroded channel along skid road upstream of C2

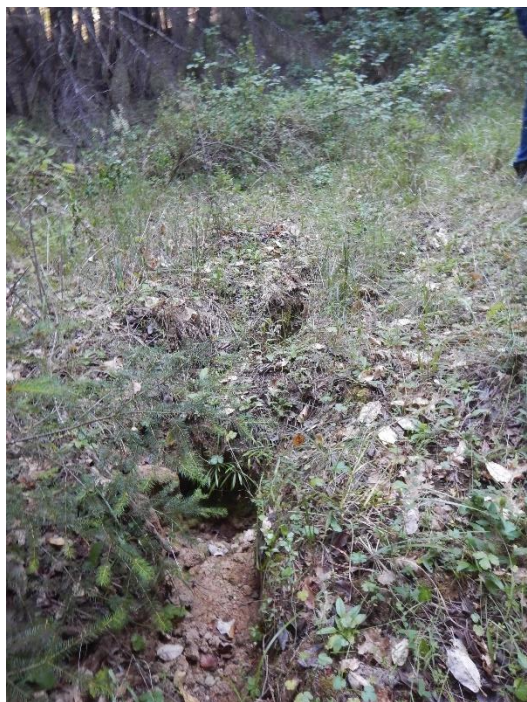
Photo 6: Picture of downstream side of C2

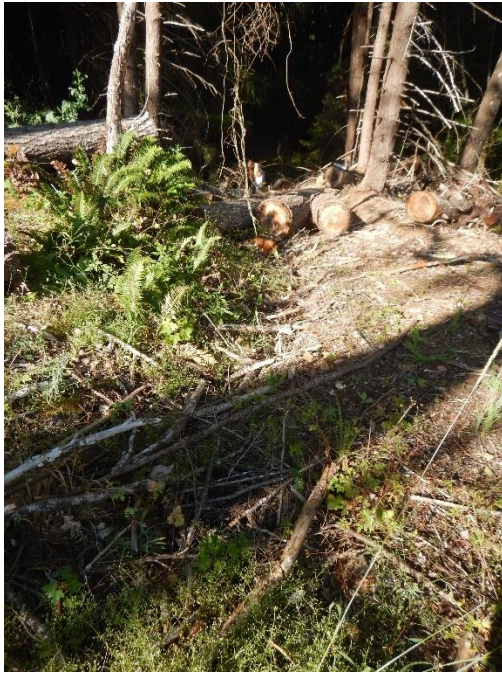
The active cultivation area, called OG1 in this report (not labeled on Figure 1), is located in the north-central portion of the Property in the large clearing, just south of C5 and near points TOC1, TOC2, and TOC3. OG1 is located in a flat depression that, with no anthropogenic alternations, appears would receive channelized flow from two distinct watercourses up-gradient. The two watercourses have been diverted from their natural flow paths. One flows behind the main structure on the northeast portion of OG1, then into a watercourse crossing (C5 on Figure 1), eventually delivering to another class III watercourse below. The second watercourse is diverted along the access road leading to OG1 (Photos 18-20) along the southern side of the clearing near several water storage tanks (T1-3 on Figure 1), where it disperses into a vegetated area. Just downslope from where the second channel disperses, and approximately 25 feet from the cleared area associated with OG1, I observed evidence of channelized flow and a class III watercourse (Photos 7-9), labeled as TOC2 on Figure 1. TOC2 was not disclosed in the WRPP.

Photo 7: Channel downslope from TOC2, leading towards C2

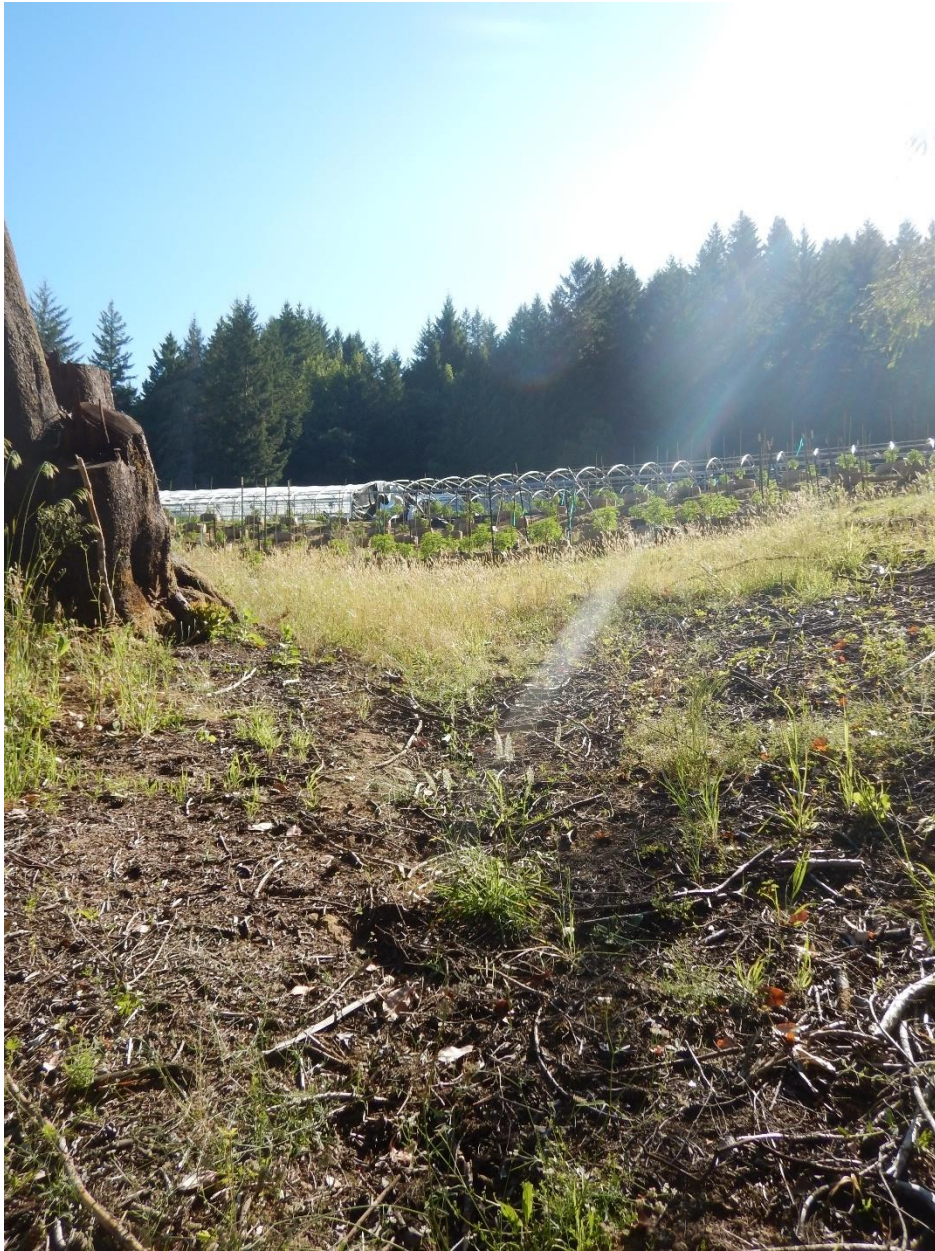
Photo 8: TOC2, with cultivation area in background

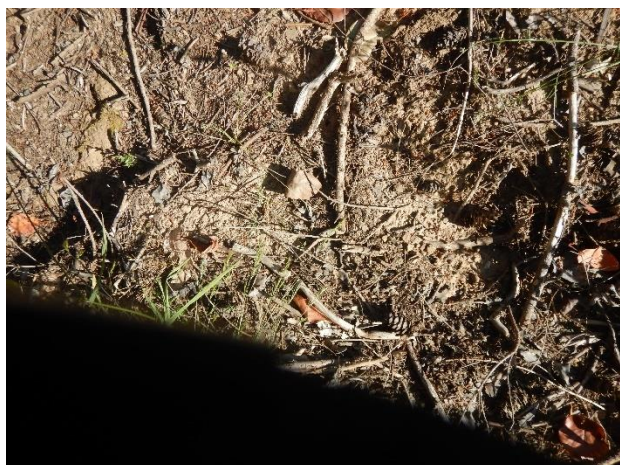
Photo 9: Fine sediment deposition within channel near TOC2

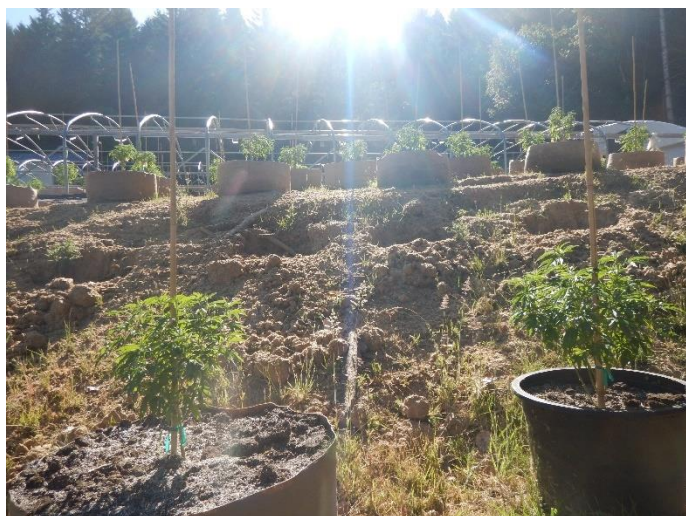
Photo 10: Terrace area of OG1 with failing hillslope above TOC2

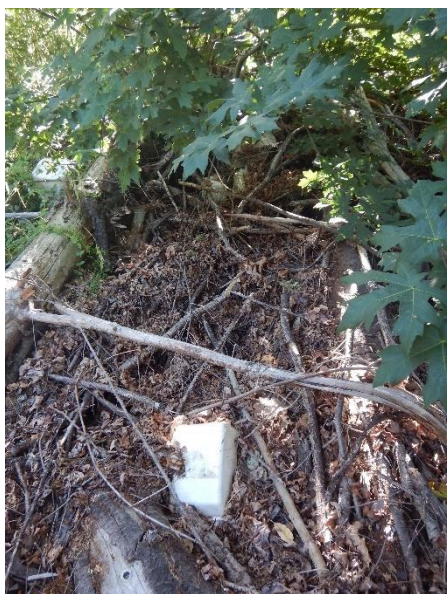
Along the north side of OG1, I observed a third headwater stream, TOC3 on Figure 1, located 3 feet from outdoor cannabis cultivation activities and 32 feet from a greenhouse structure (Photos 12-13). Near this point I observed a large pile of soil amendments near the watercourse, and discarded fertilizer containers within the channel. The watercourse channel continues downslope to point Chan1 on Figure 1, and eventually crosses an old skid road near point C3 on Figure 1 (Photo 14-15). I was unable to closely inspect the crossing feature because there were large, potentially unstable, slash piles along the road and within the watercourse, making observation difficult. TOC3, C3 and the adjacent skid road were not disclosed in the WRPP.

Photo 11: Discarded fertilizer container in channel below TOC3

4. Store and contain all chemicals, including petroleum, fertilizer and/or pesticides properly to prevent spillage and discharge to receiving waters. Provide secondary containment for all petroleum products.

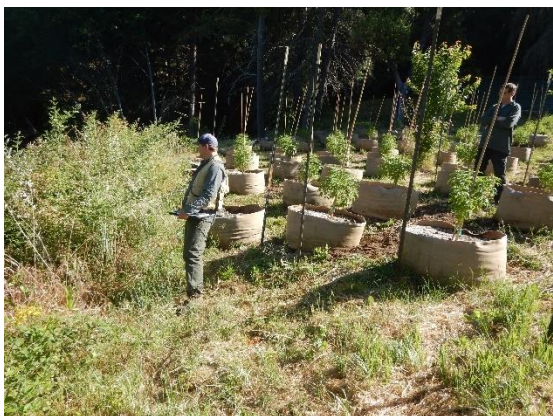
Photo 12: TOC3, person on left is looking at the top of the channel, OG1 three feet to the right

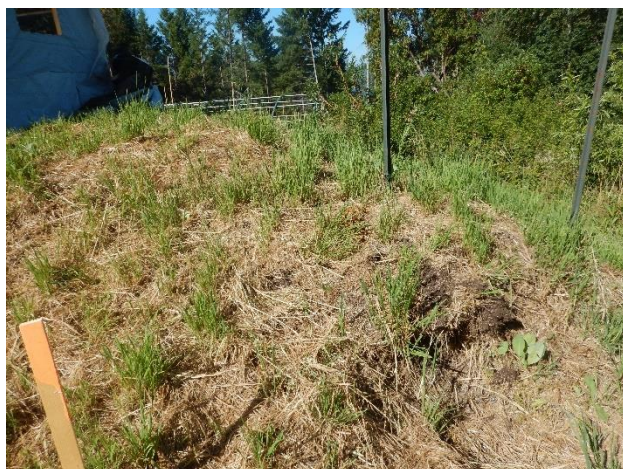
Photo 13: Cultivation related wastes, soil amendments, located within 10 feet of TOC3

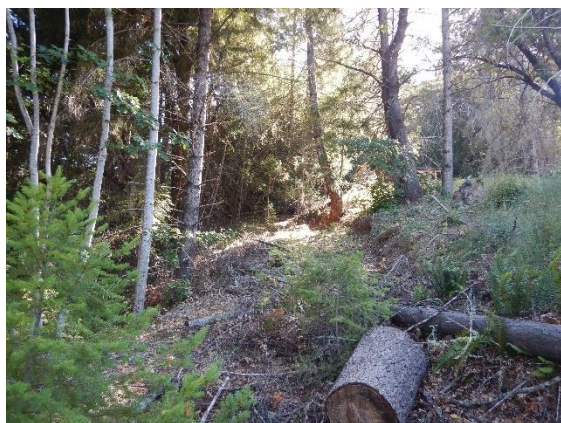
Photo 14: Skid road north of OG1

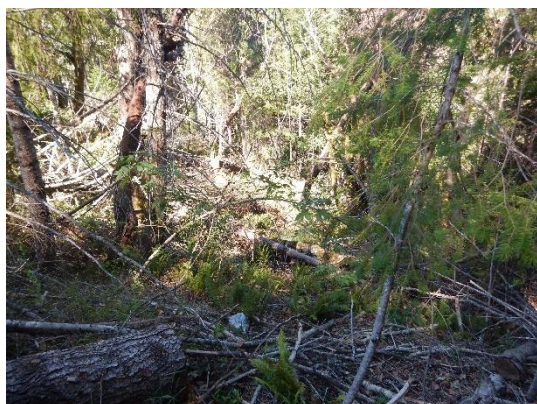
Photo 15: Slash along skid road in area near suspected crossing, C3

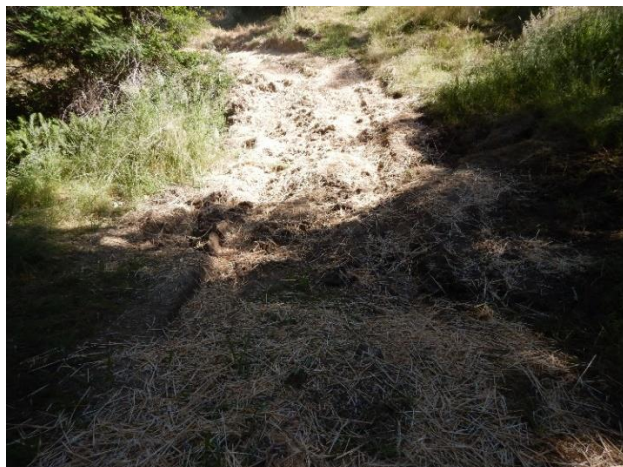
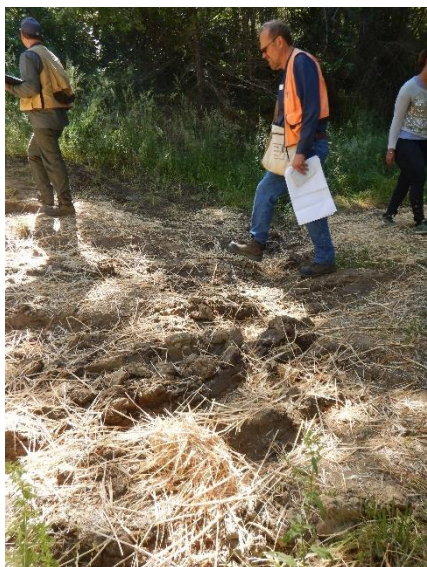
Upslope to the northwest of OG1, near a retired cultivation site, I observed a fifth watercourse crossing, C4 on Figure 1. C4 was disclosed in the WRPP and remediation of the site was attempted. During the inspection, I observed uncompacted, recently excavated, earthen material along the crossing (Photos 16-17). Mr. Cunningham indicated that, during the decommissioning of the cultivation area beyond C4, the operators also worked to decommission the crossing. I observed that straw was placed throughout the area where work was conducted, but that the general condition of the crossing was unstable and in need of further remediation.

Photo 16: Crossing, C4

Photo 17: Crossing, C4

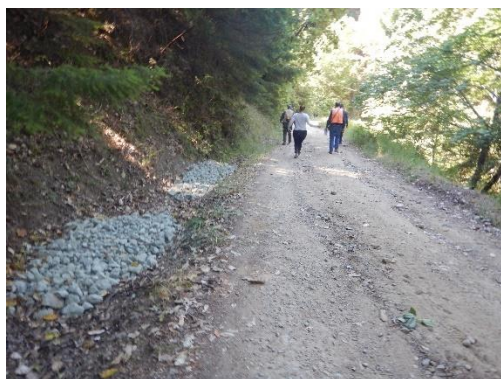
Photo 18: Main access road inboard ditch

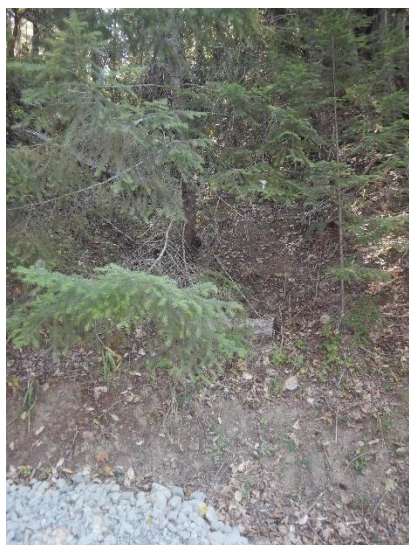
Photo 19: Watercourse feature, swale, immediately upslope of main access road, Chan2

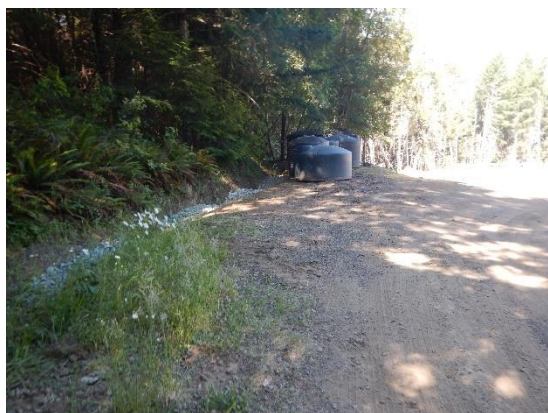
Photo 20: Inboard ditch of main access road near OG1

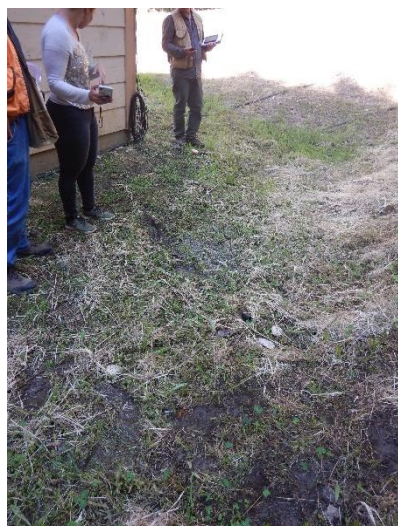
To the immediate north of OG1, and east of TOC3, I observed a fourth watercourse crossing, C5 on Figure 1 (Photos 21-23). C5 consists of a dirt ford crossing along a class III watercourse and lacks appropriate rock armoring and flow conveyance design features. Water crossing C5 continues downslope and delivers to a class II watercourse below. C5 was not disclosed in the WRPP.

Photo 21: Class II / seep coming from hillside downslope of intercepted swale / watercourse feature upslope of C5

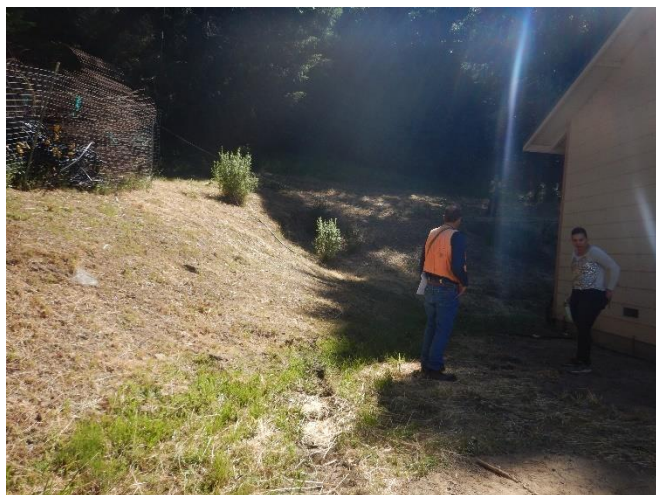
Photo 22: Class II drainage downslope of the class II / seep adjacent to the main house structure on the eastern edge of OG1, leading towards C5

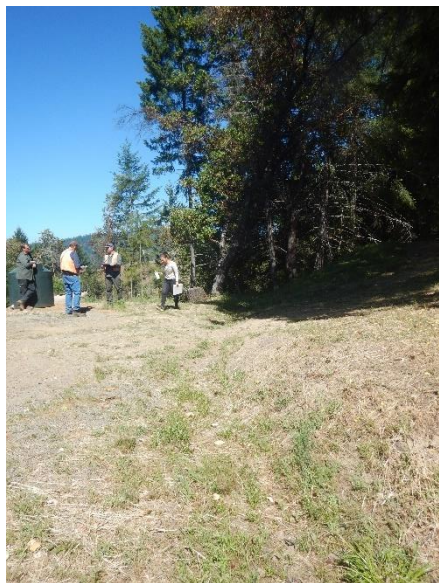
Photo 23: Class III drainage leading to C5, C5 in background near rightmost person

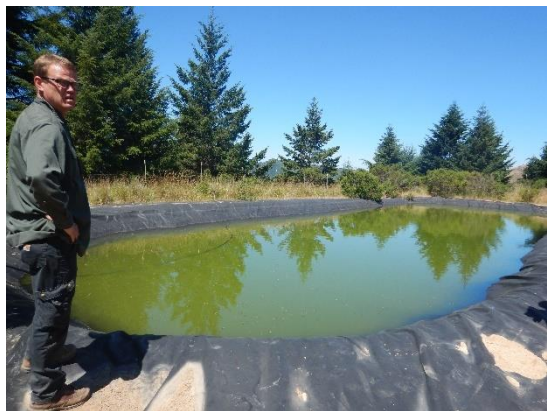
Upslope from TOC4, along the northeastern corner of the Property, I observed a second, off-stream impoundment, P2 on Figure 1. P2 consists of an earthen berm that lacks any overflow conveyance infrastructure (Photo 24). P2 was disclosed in the WRPP.

Photo 24: Impoundment, P2

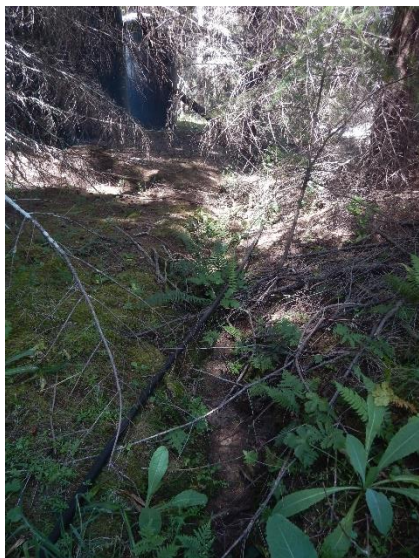
Photo 25: Class III channel near TOC4, T1-3 in background

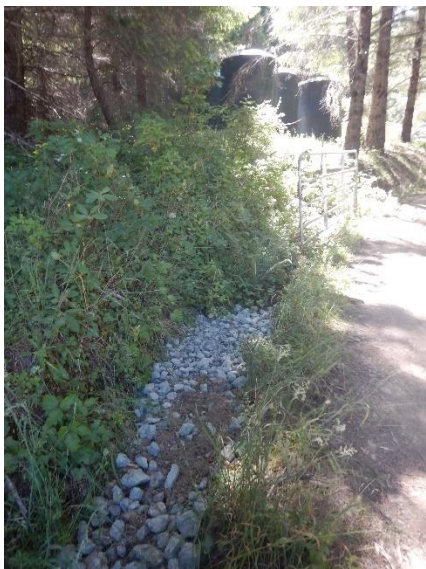
Photo 26: Class III channel / inboard ditch along main access road, downstream of T1-3

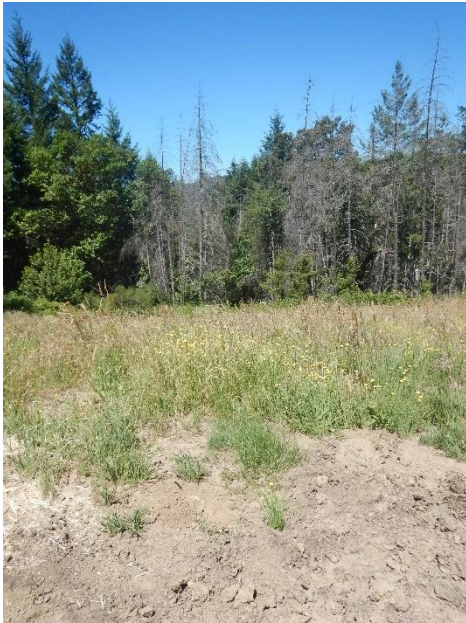
Further upslope, along the main access road, I observed evidence of a watercourse channel (Photos 27), labeled Chan2 on Figure 1. The channel is diverted along the inboard ditch of the main access road and appears to deliver its contents onto a grassy flat that was associated with a former, retired, cultivation site. The channel extends upslope to its headwaters, labeled TOC4 on Figure 1. Between TOC4 and Chan2, I observed several water storage tanks (Photos 25-26). The tanks were located within 10 feet of the watercourse. The water storage tanks were disclosed in the WRPP, but the adjacent channel was not. Twenty feet upslope from TOC4, I observed a third remediated cultivation site. This site was disclosed in the WRPP.

Photo 27: Delivery point of class III channel, near point Chan2
